TECHNICAL INSPECTION REPORT
CONFIDENTIAL

U.S. S. SALT LAKE CITY (CCA 25)

VOLUME 2 OF 2

OPERATION CROSSROADS

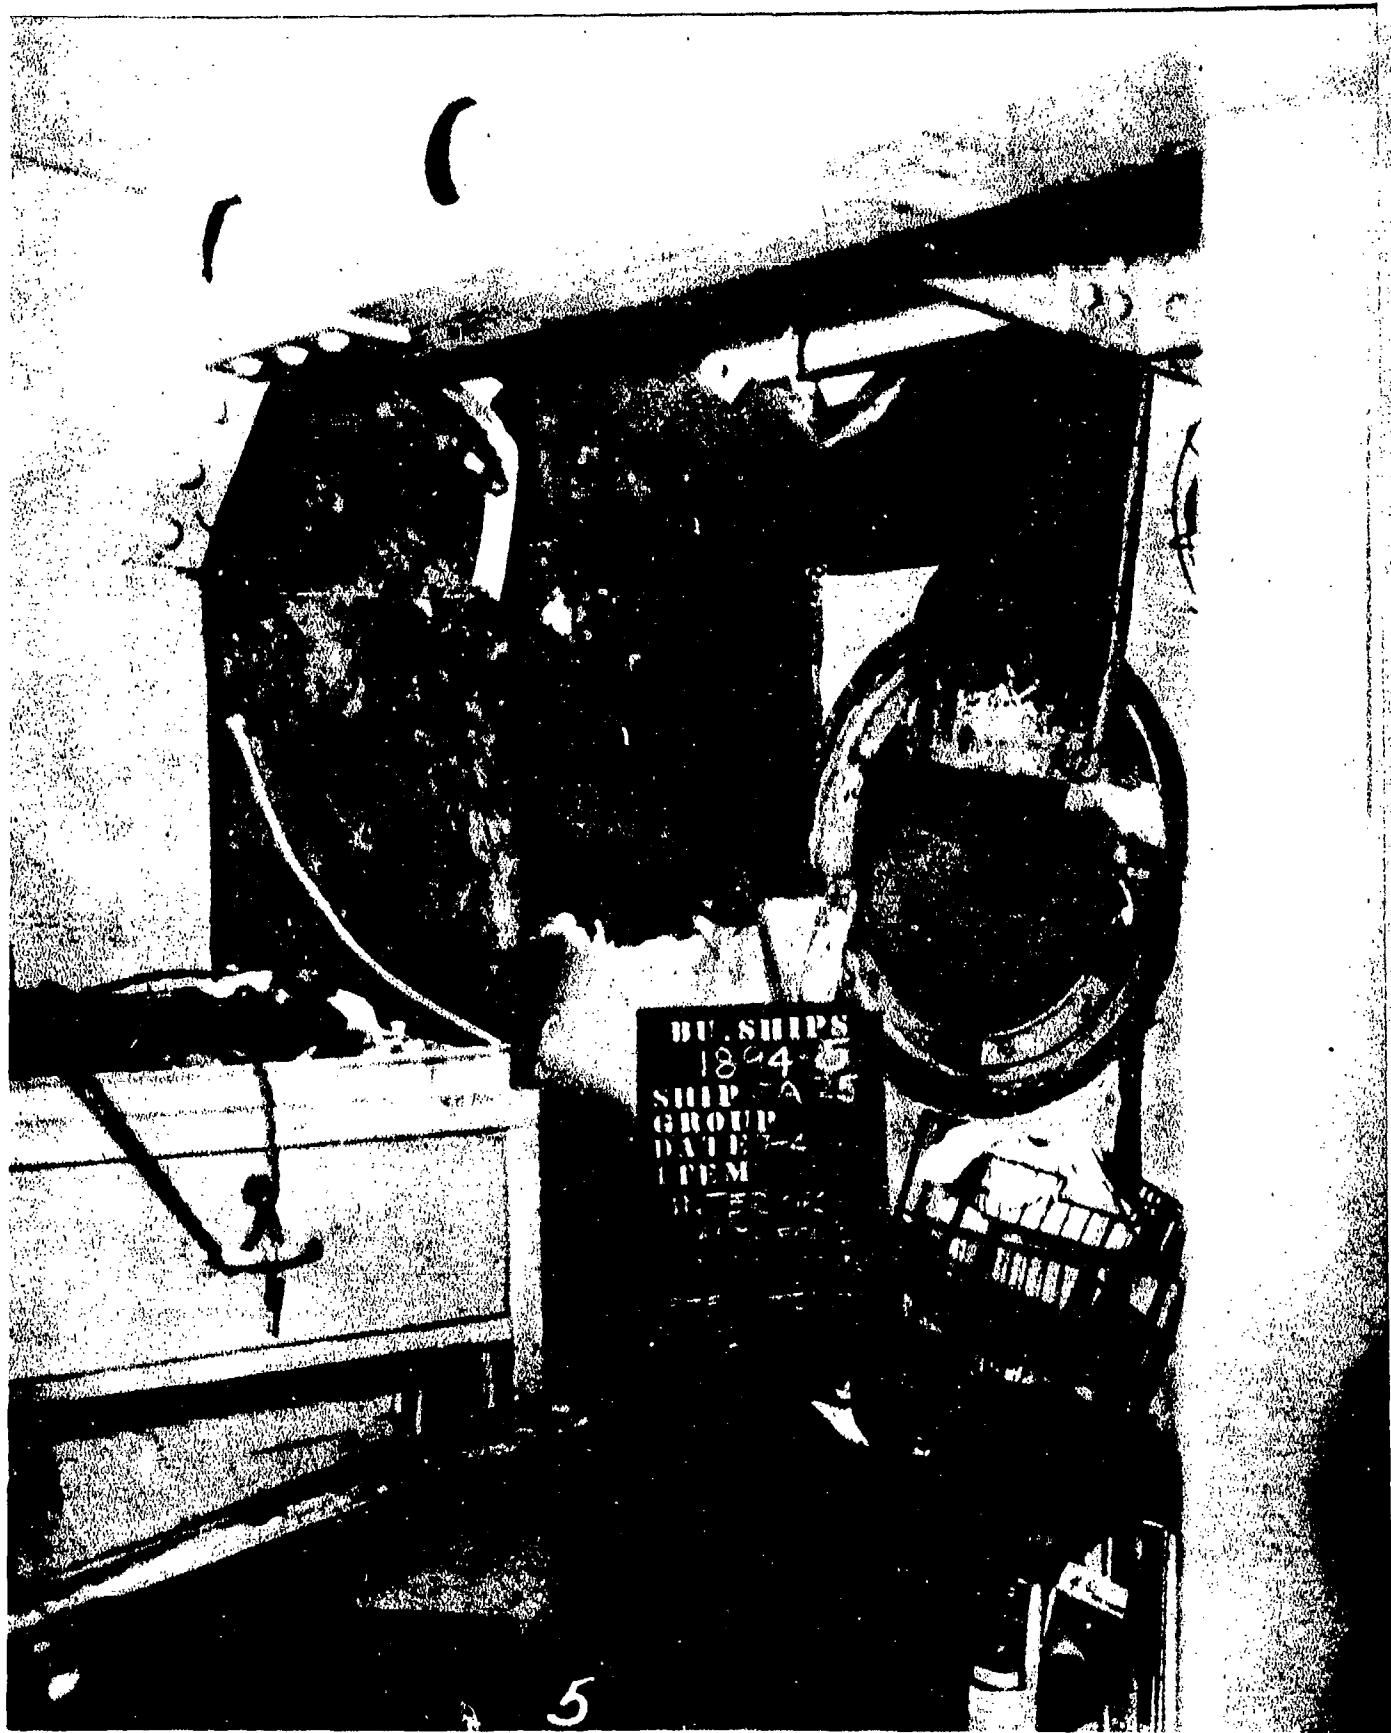
AA-CR-80-1894-5. Interior view showing port after corner of state-room 108, superstructure deck, frame 48, port.

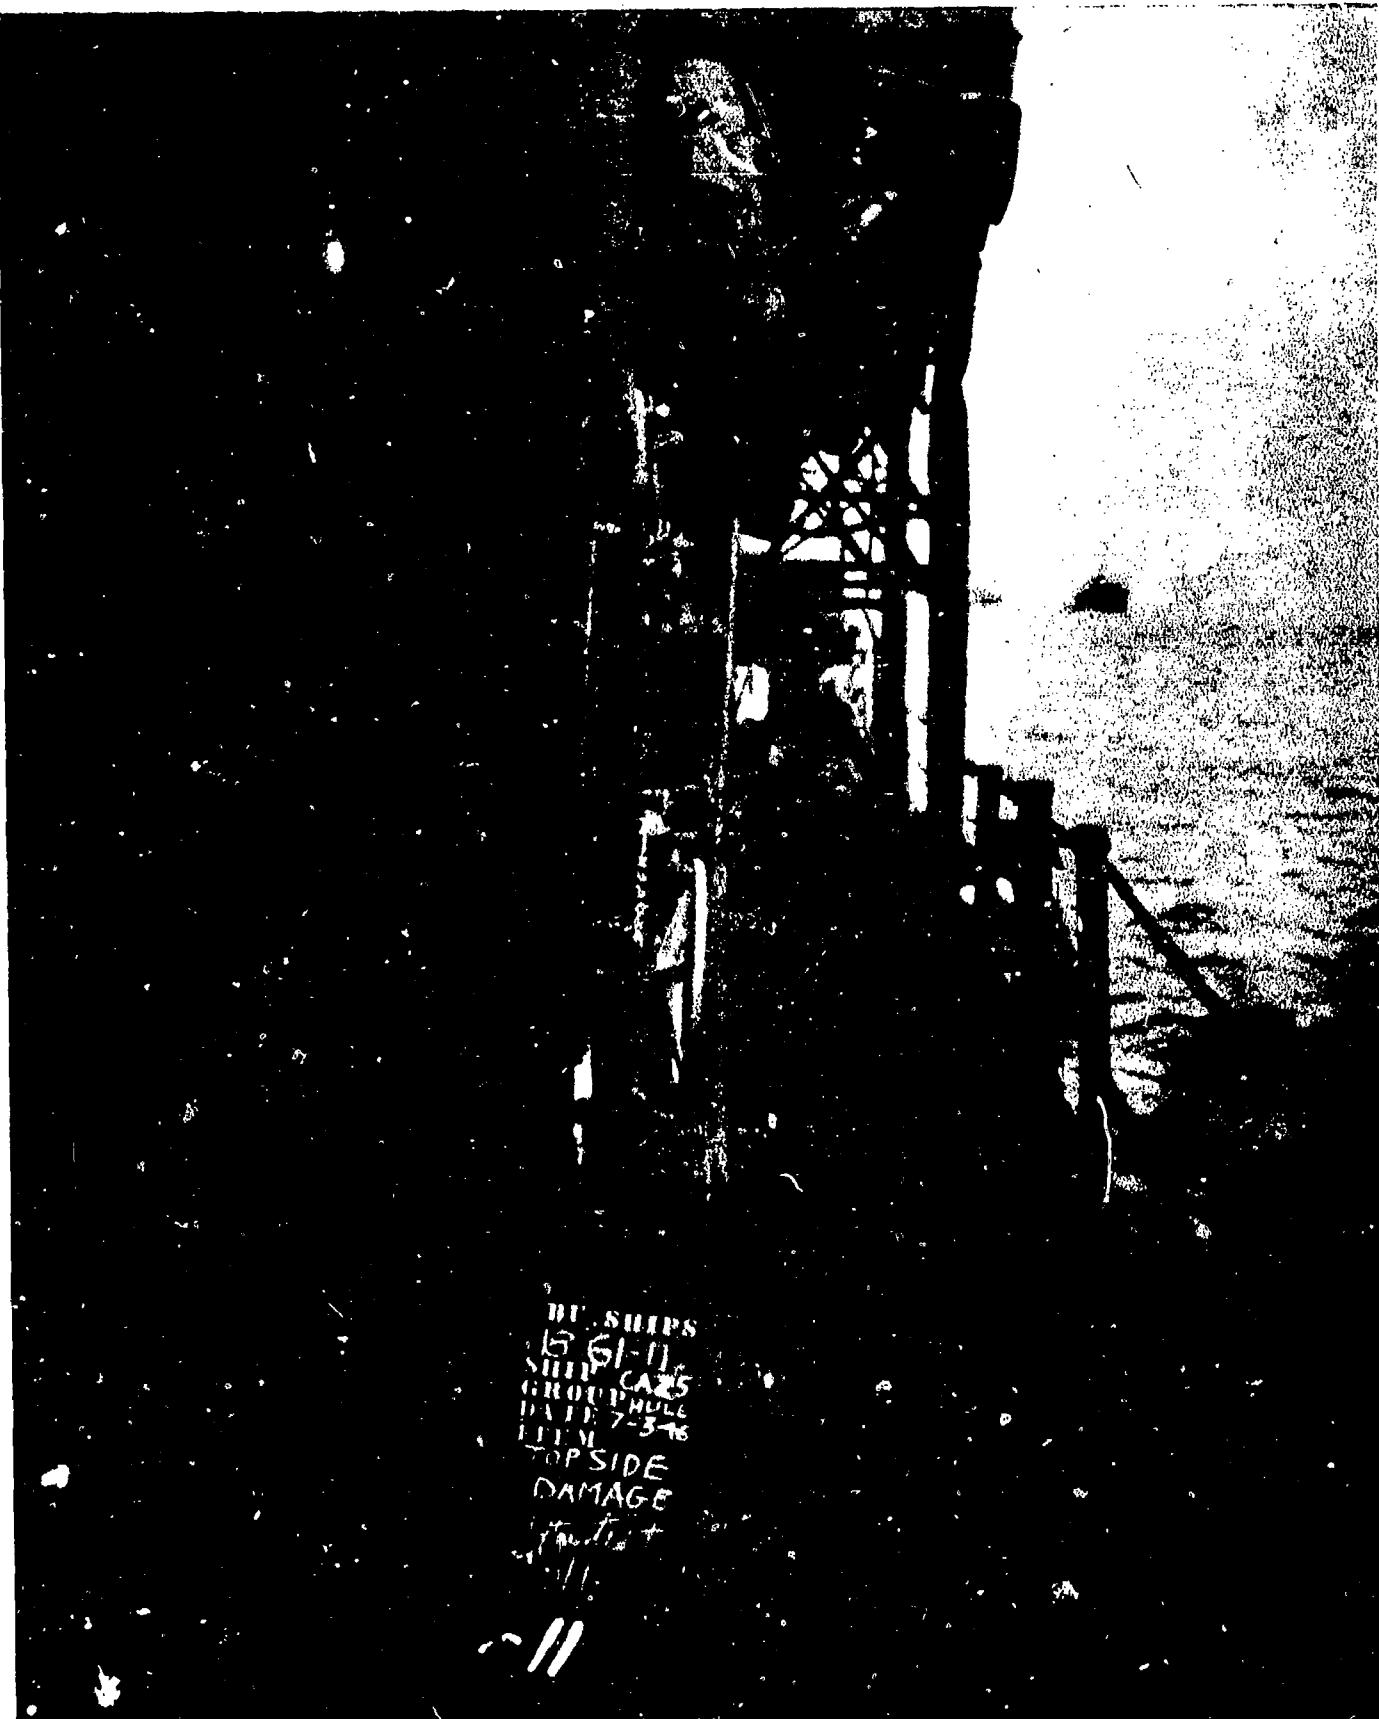
AA-CR-62-1861-11. Dished door at frame 35, port main deck, stiffener on door is broken in way of previous weld failure.

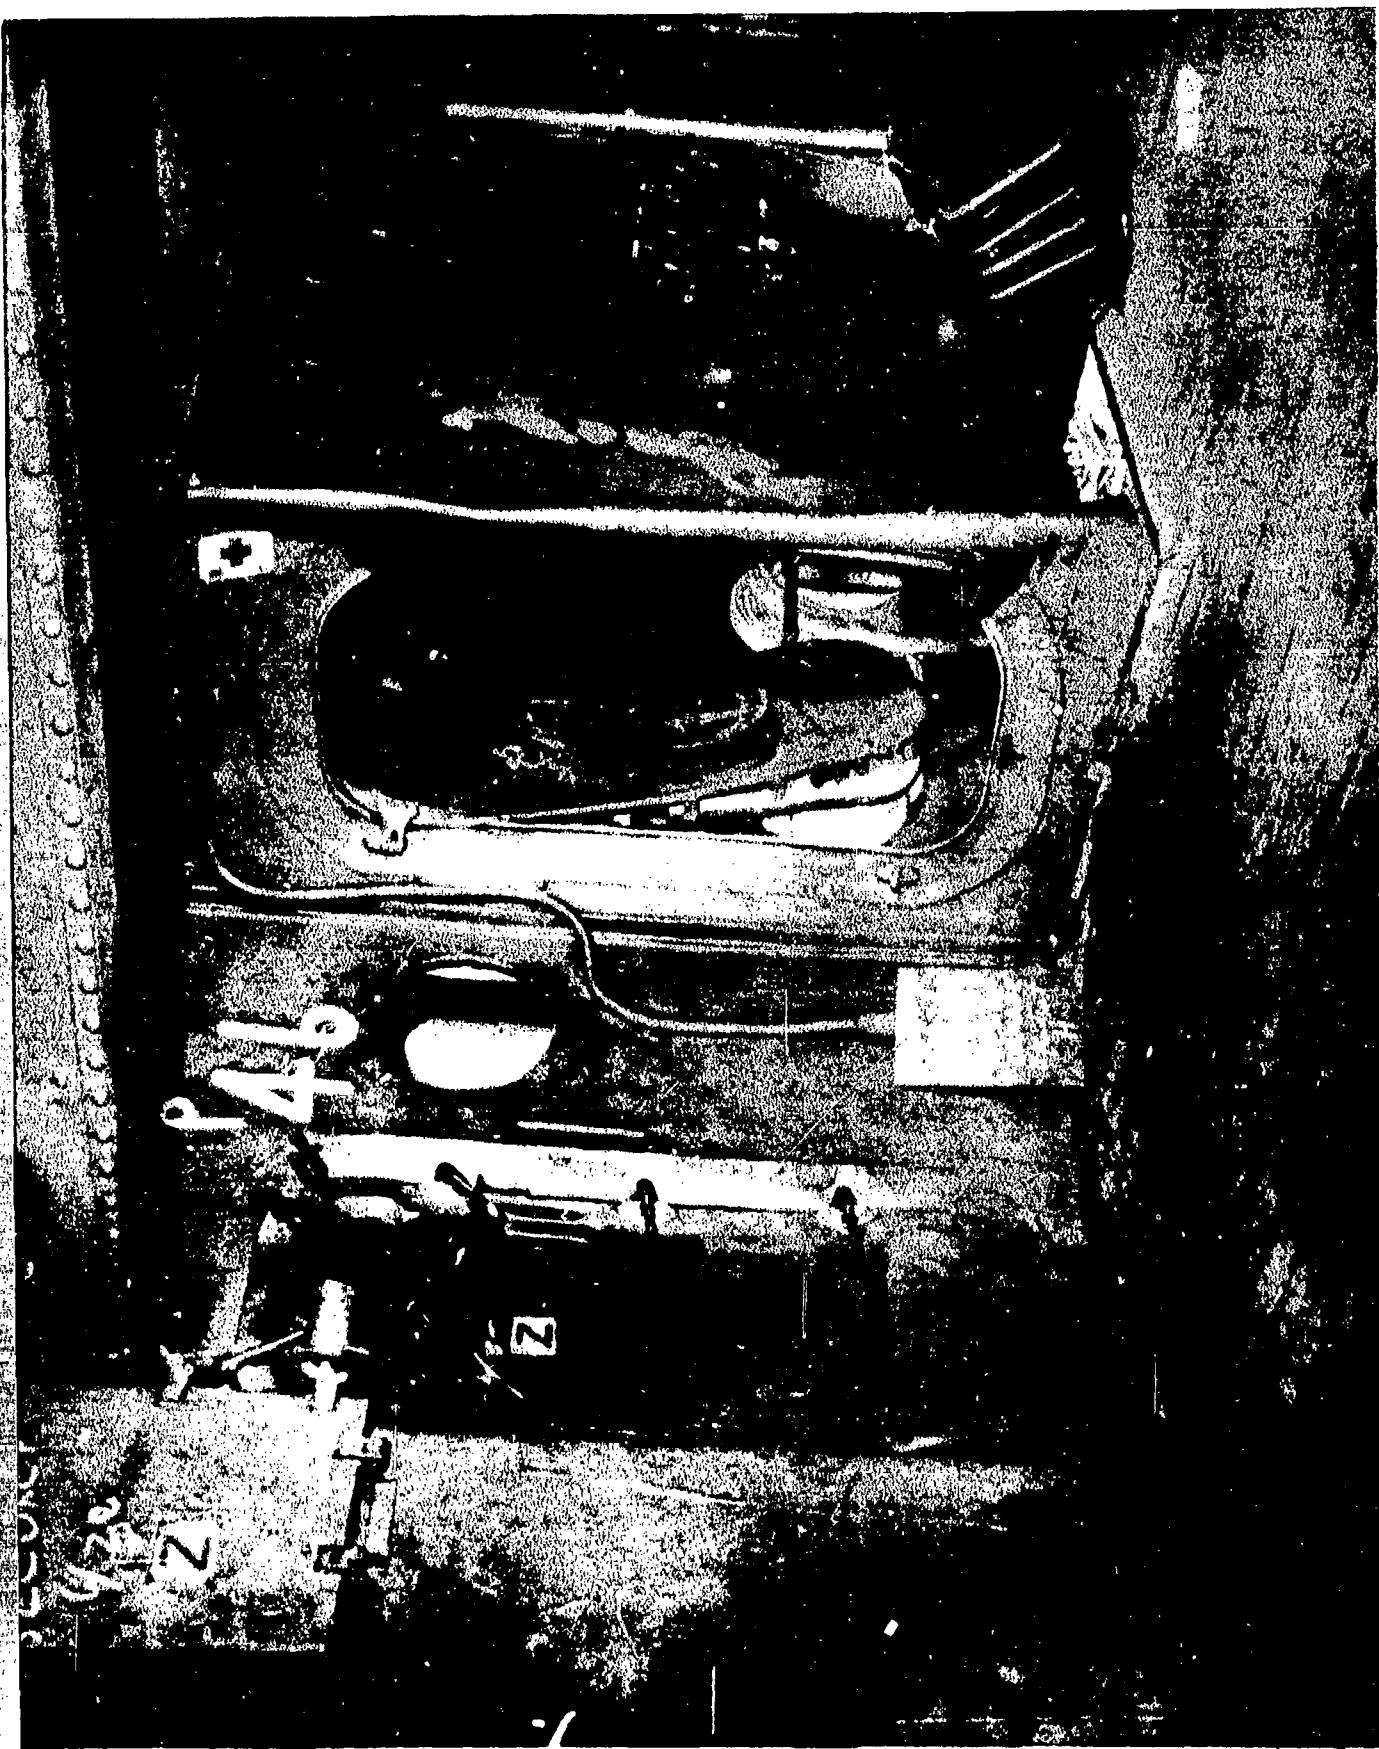
AA-CR-62-1866-1. Looking to starboard at damaged doors, door frame, and bulkhead in transverse passageway main deck, frame 49, port.

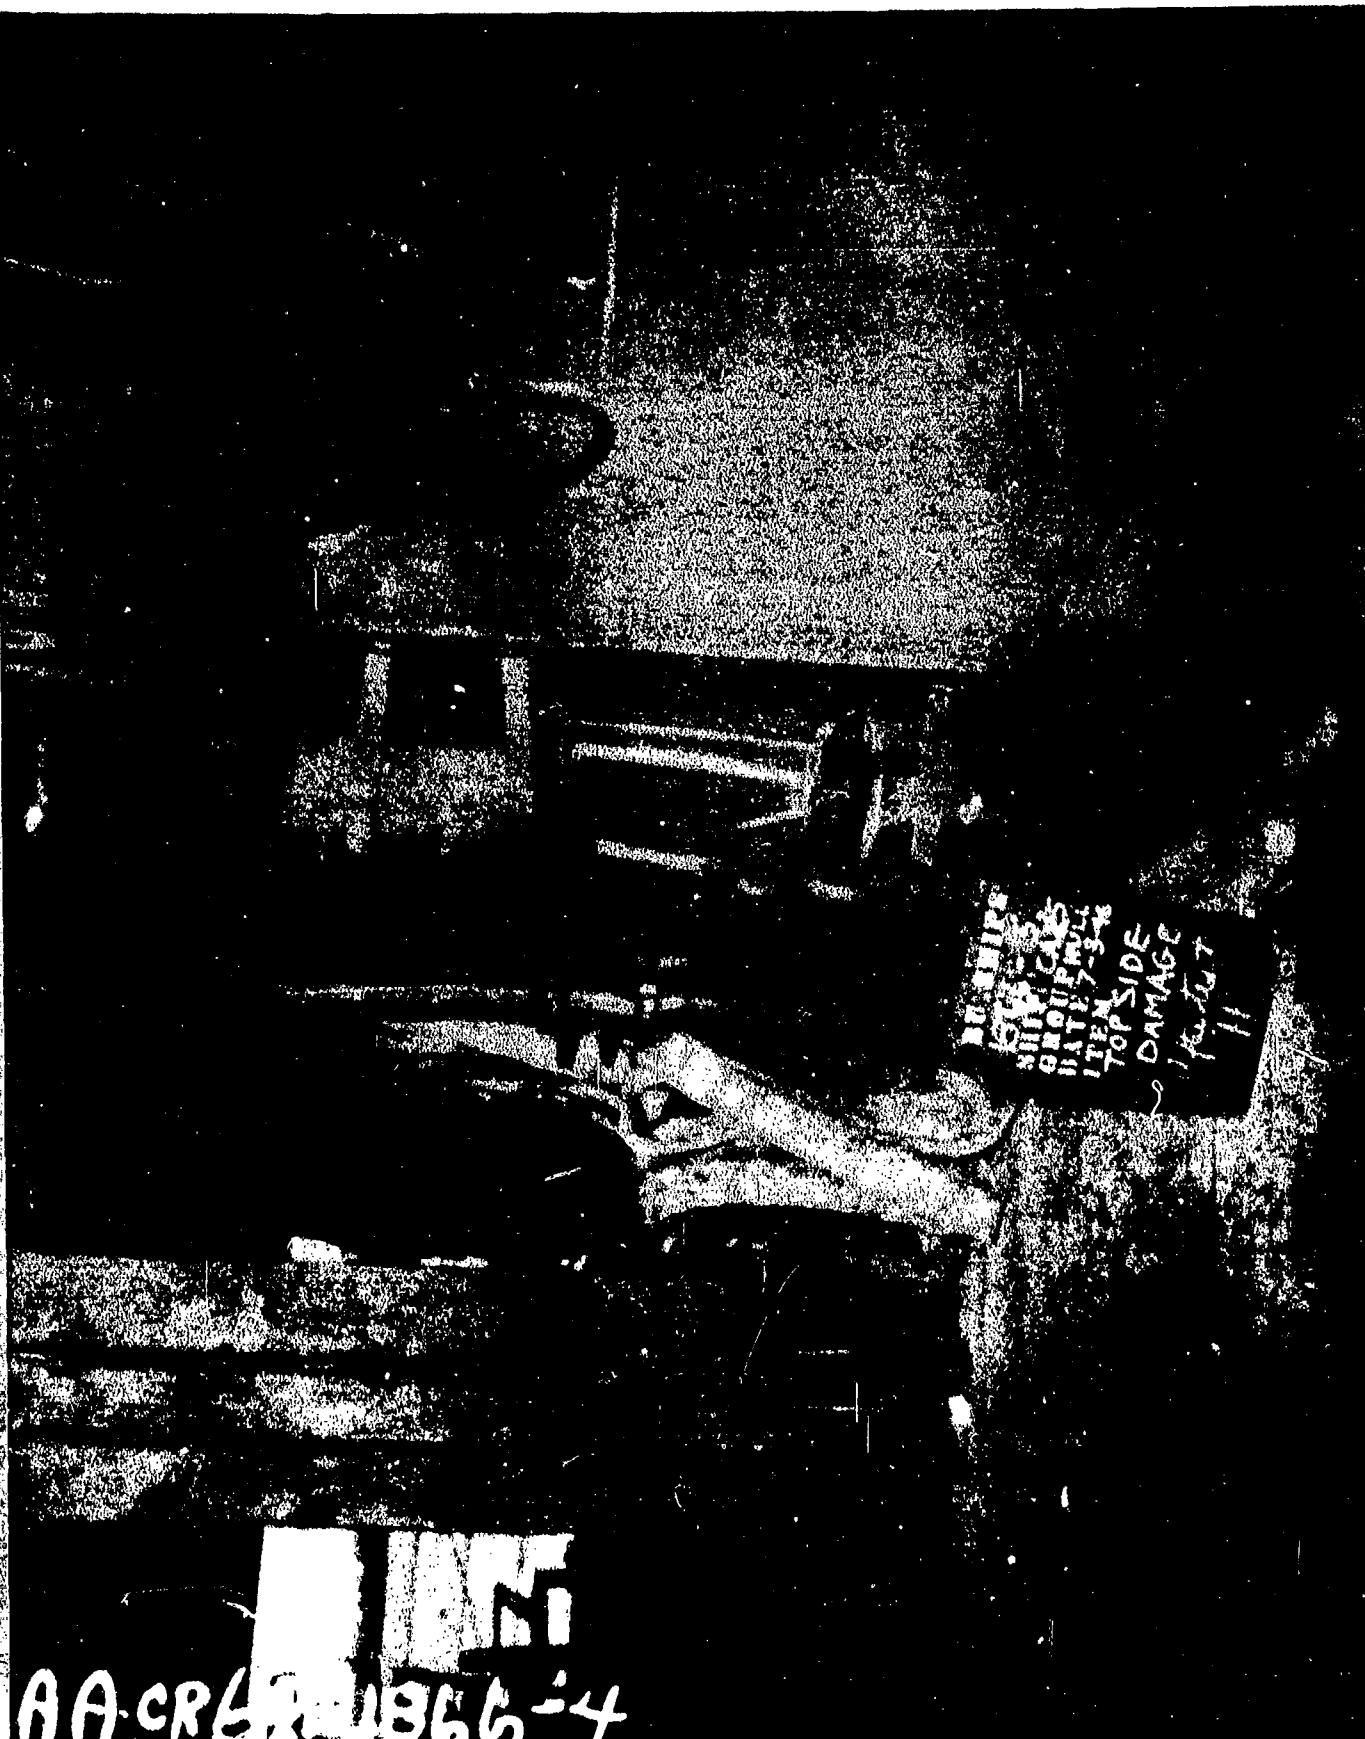
AA-CR-62-1866-4. Looking to starboard at dished structure and bent piping in transverse passageway main deck, frame 49, port.

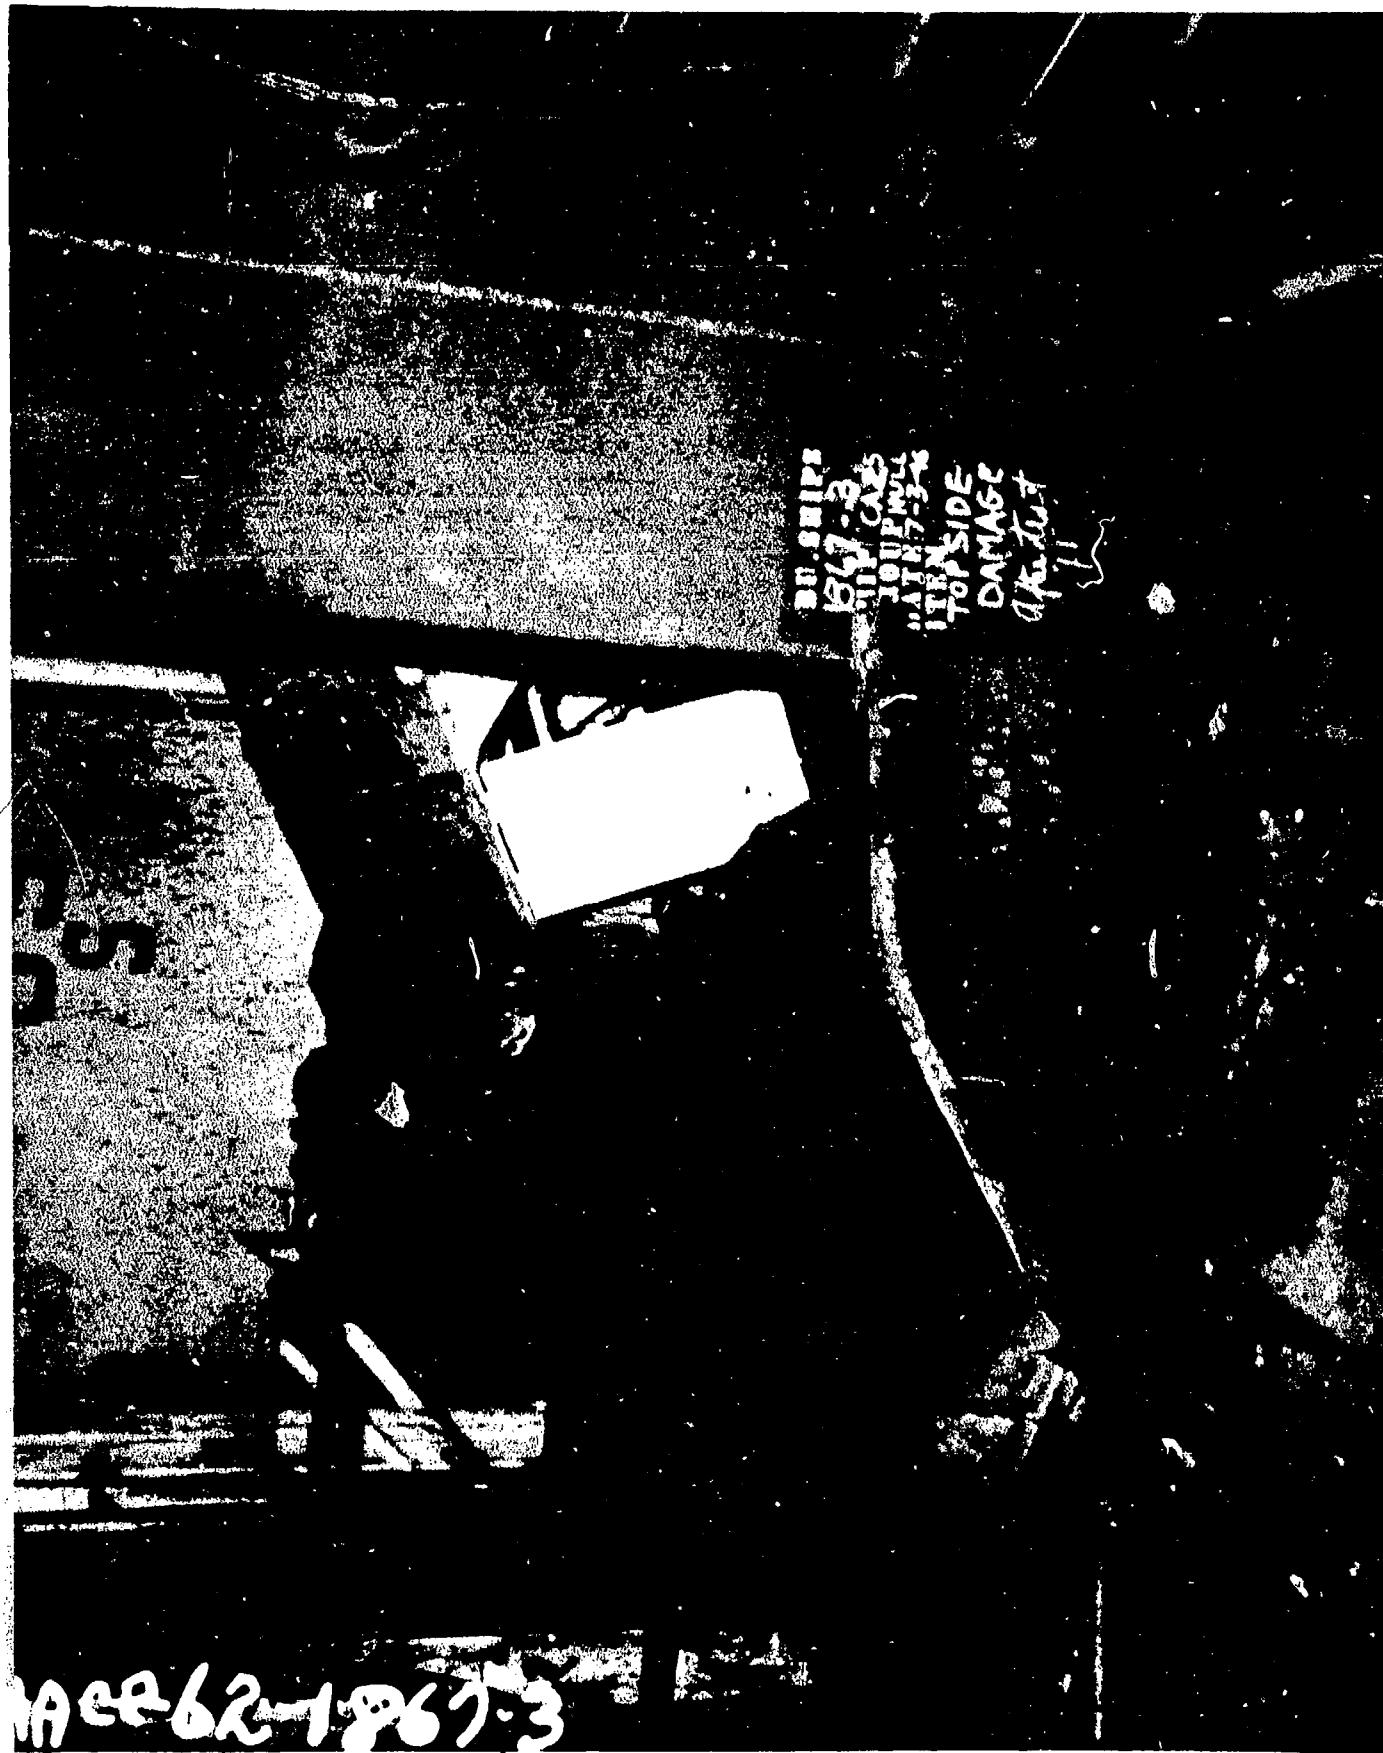
AA-CR-62-1867-3
AA-CR-62-1867-3. Looking forward at door to boat engine repair shop,
main deck, frame 92, starboard.

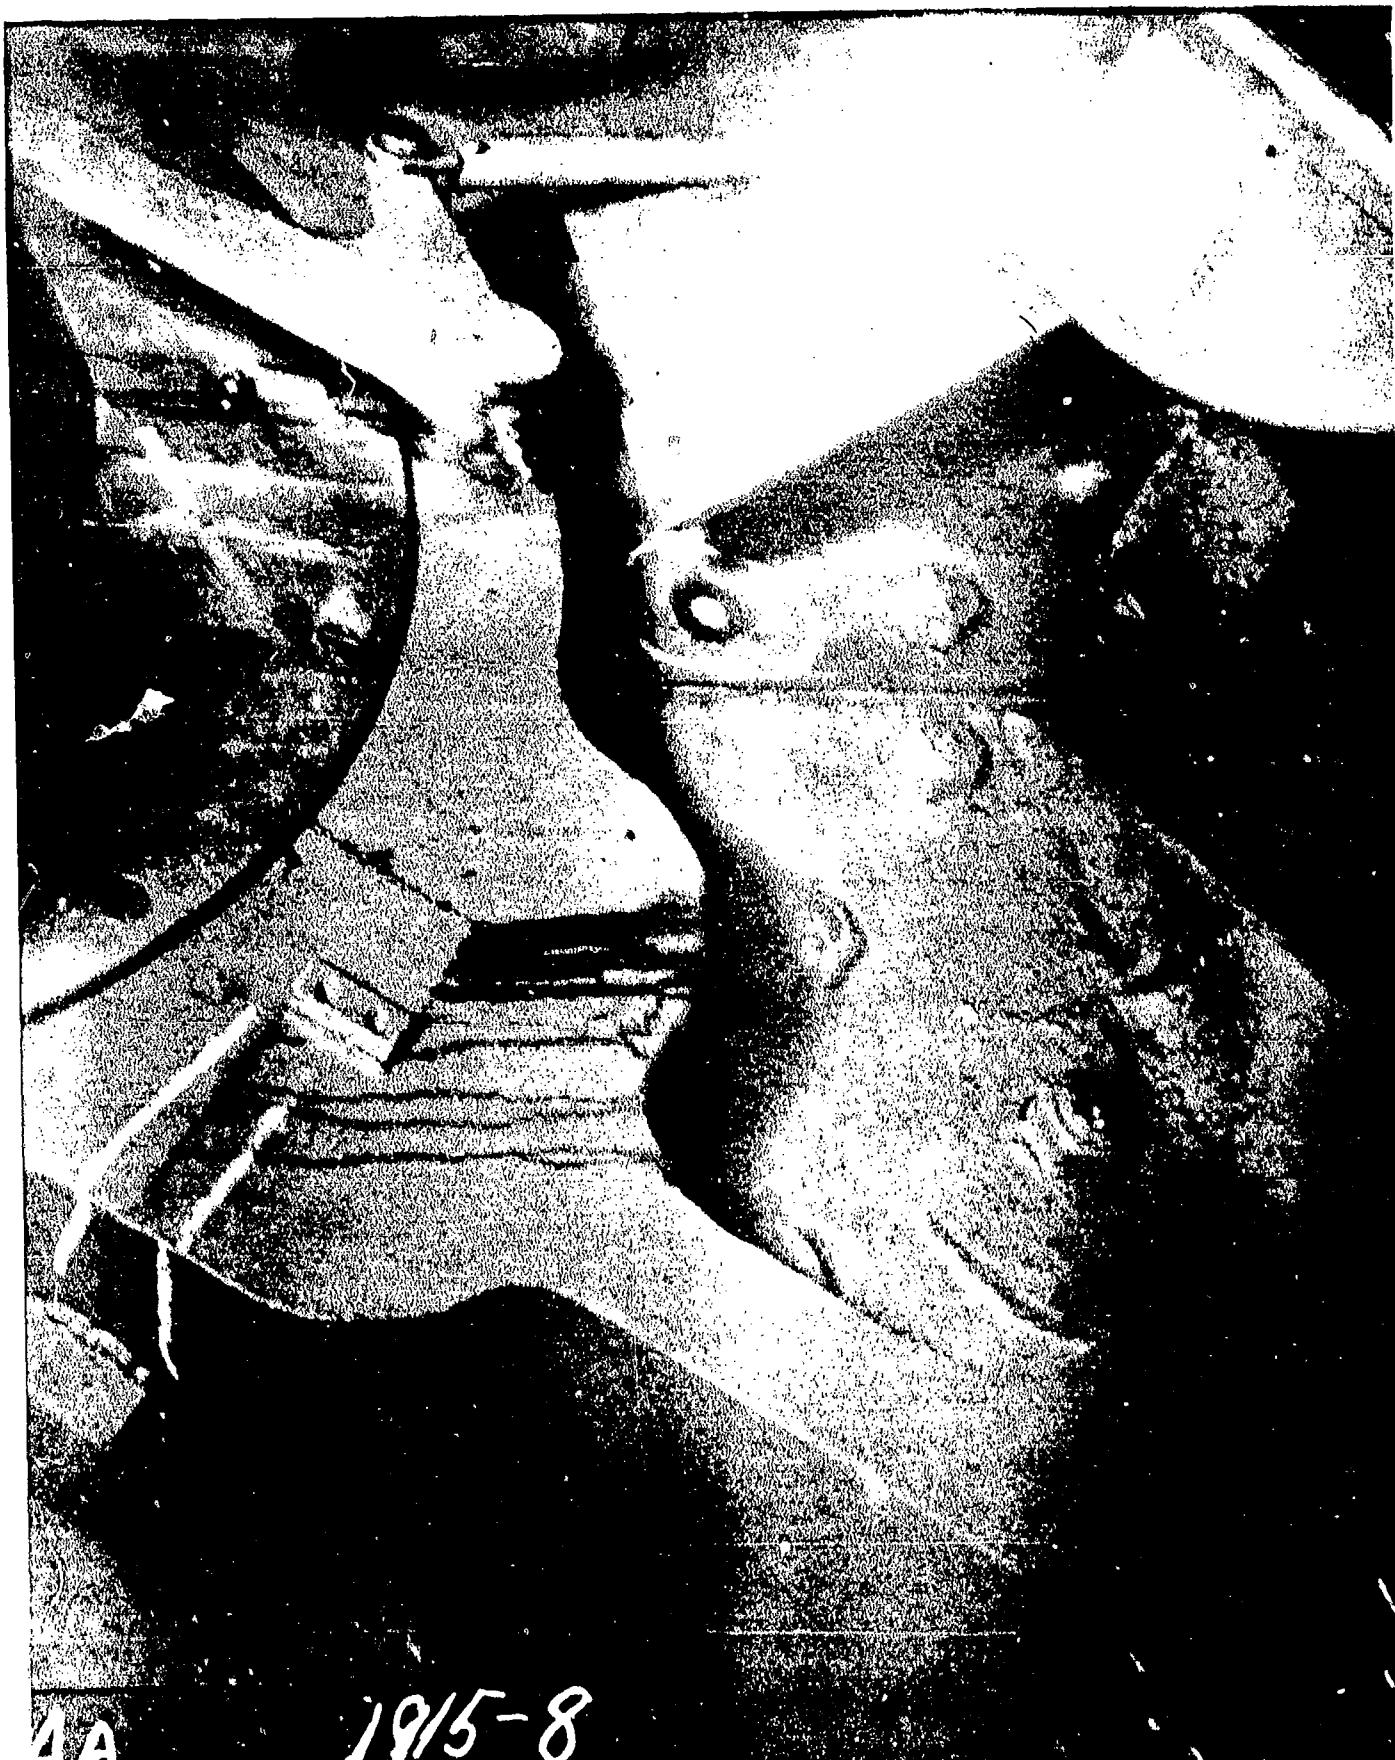
AA-1915-8

AA-CR-82-1915-8. Mount No. 2, left trunnion support looking to right and rear.

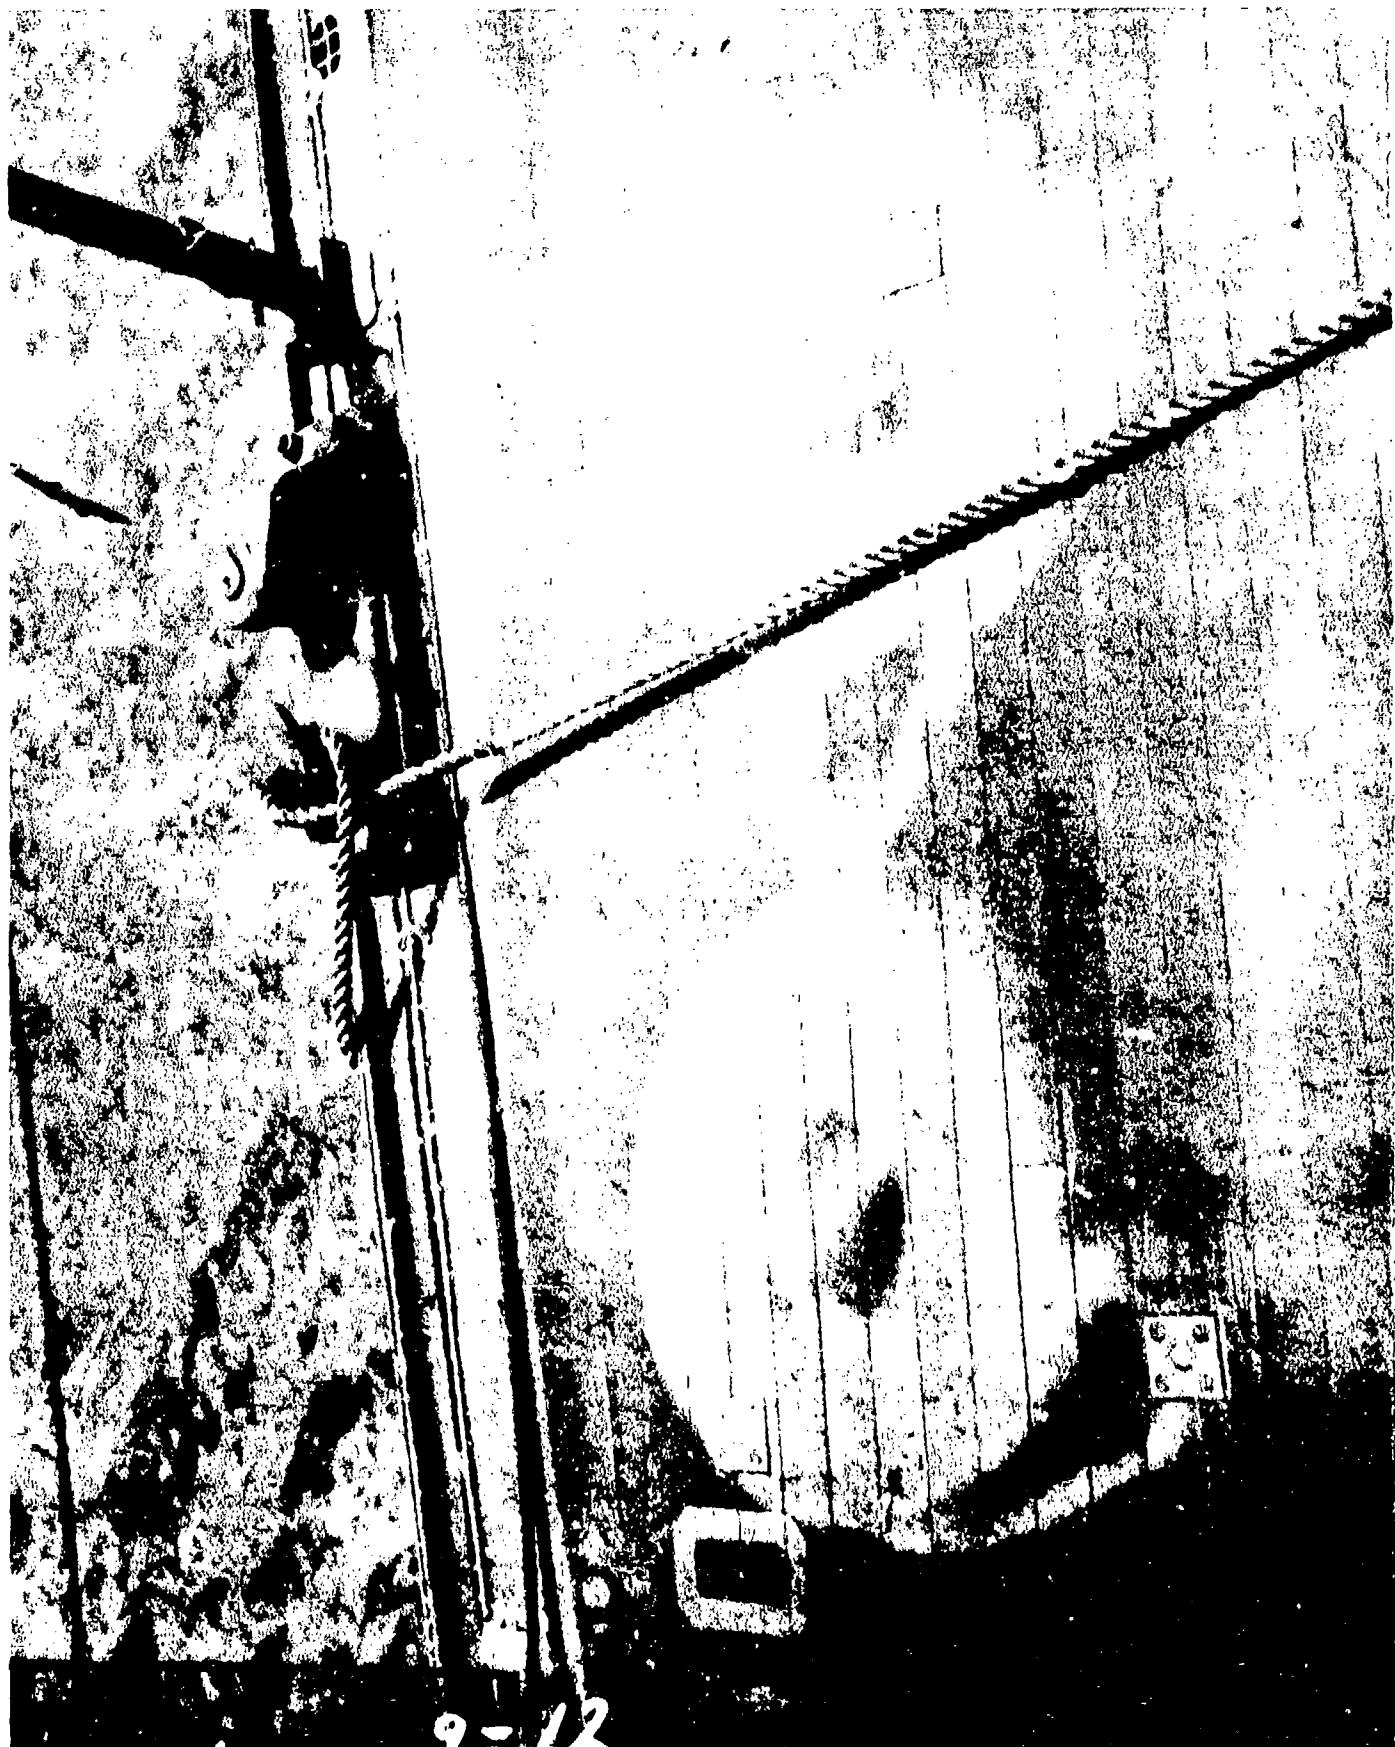
AA-CR-65-1729-12. Main deck, frame 130, starboard. Typical shadow imprint.

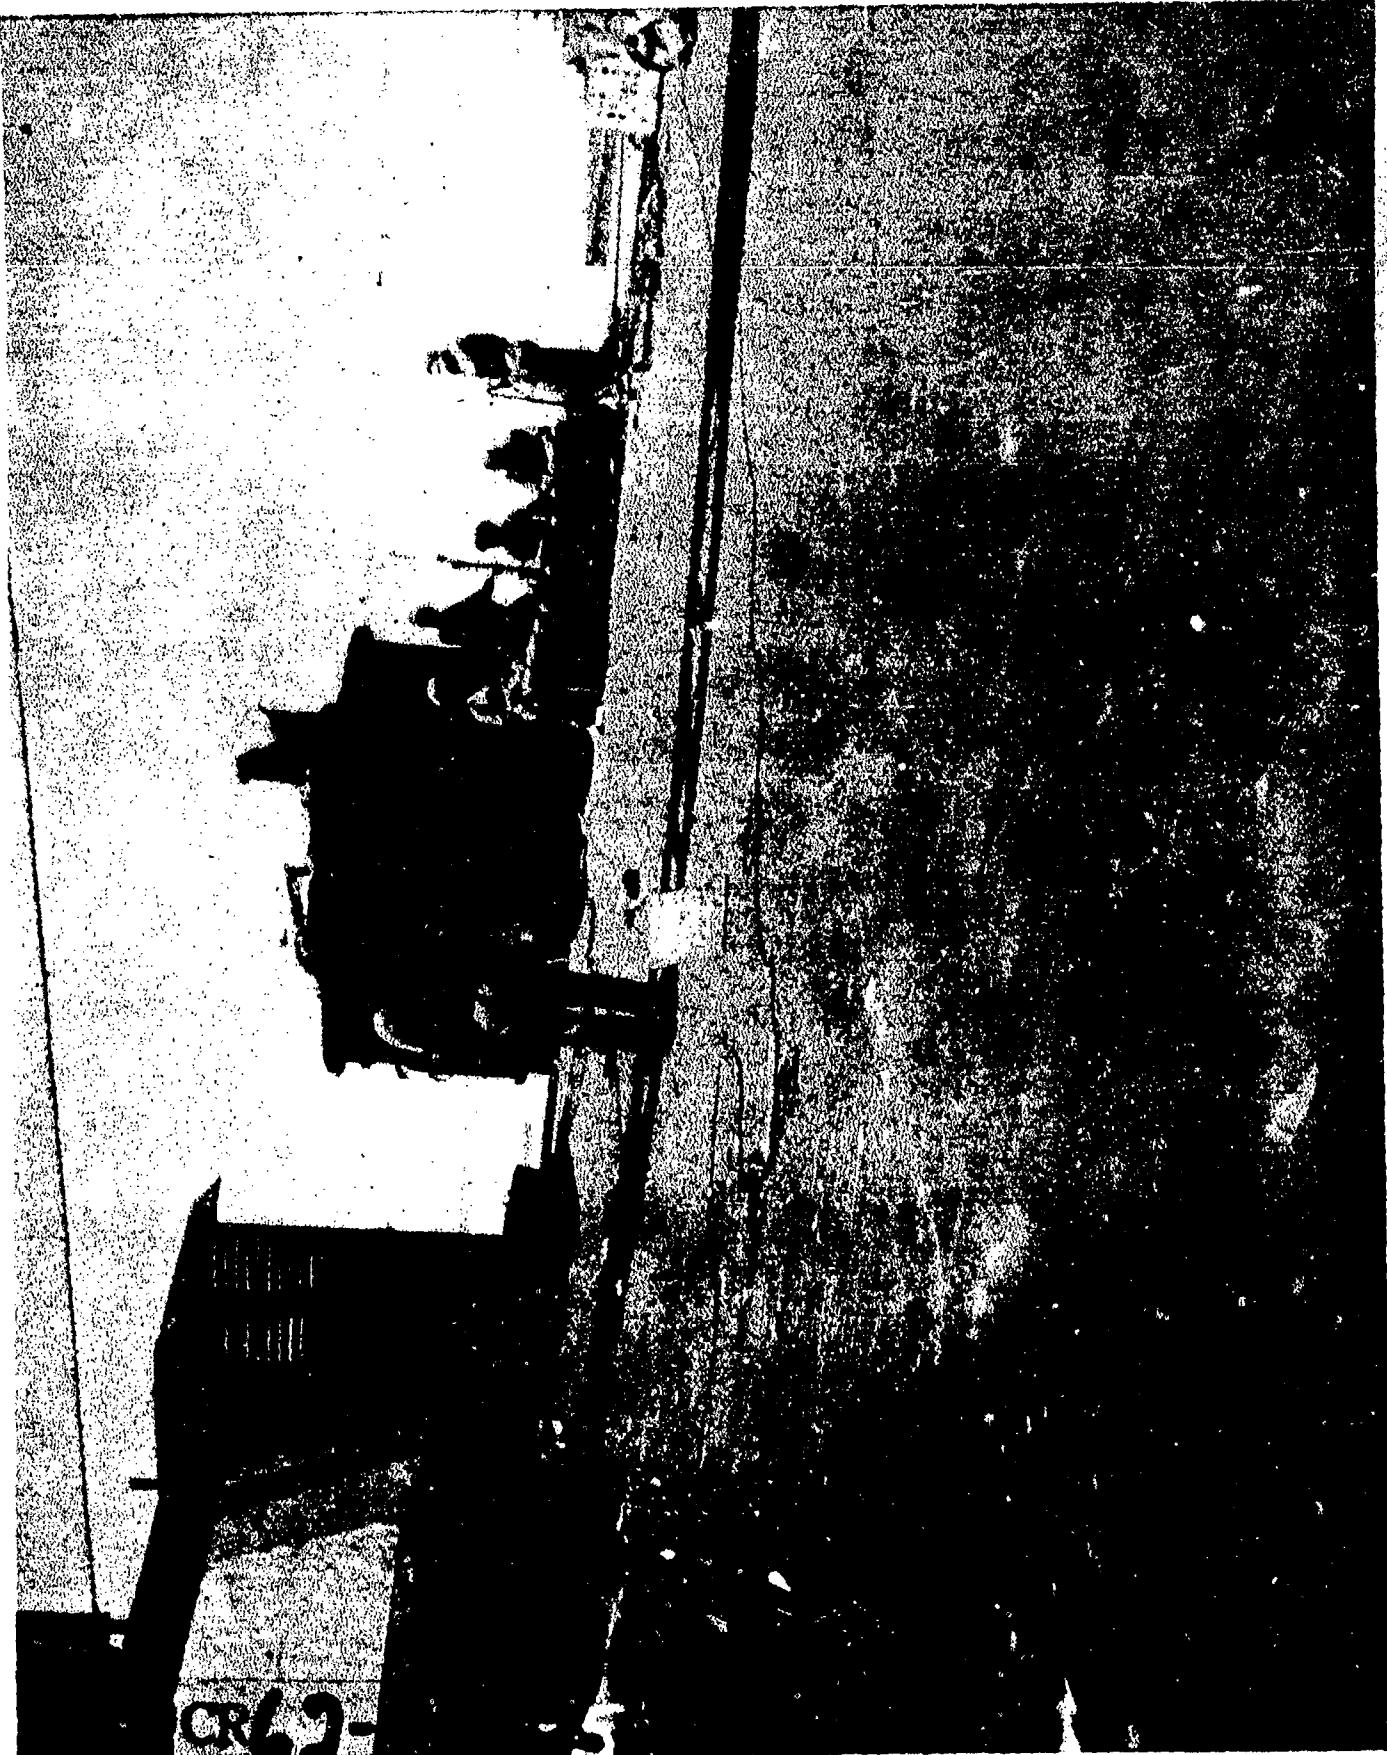
AA-CR-62-1866-5. Looking forward and to starboard at sagged area of main deck, frames 61 to 73.

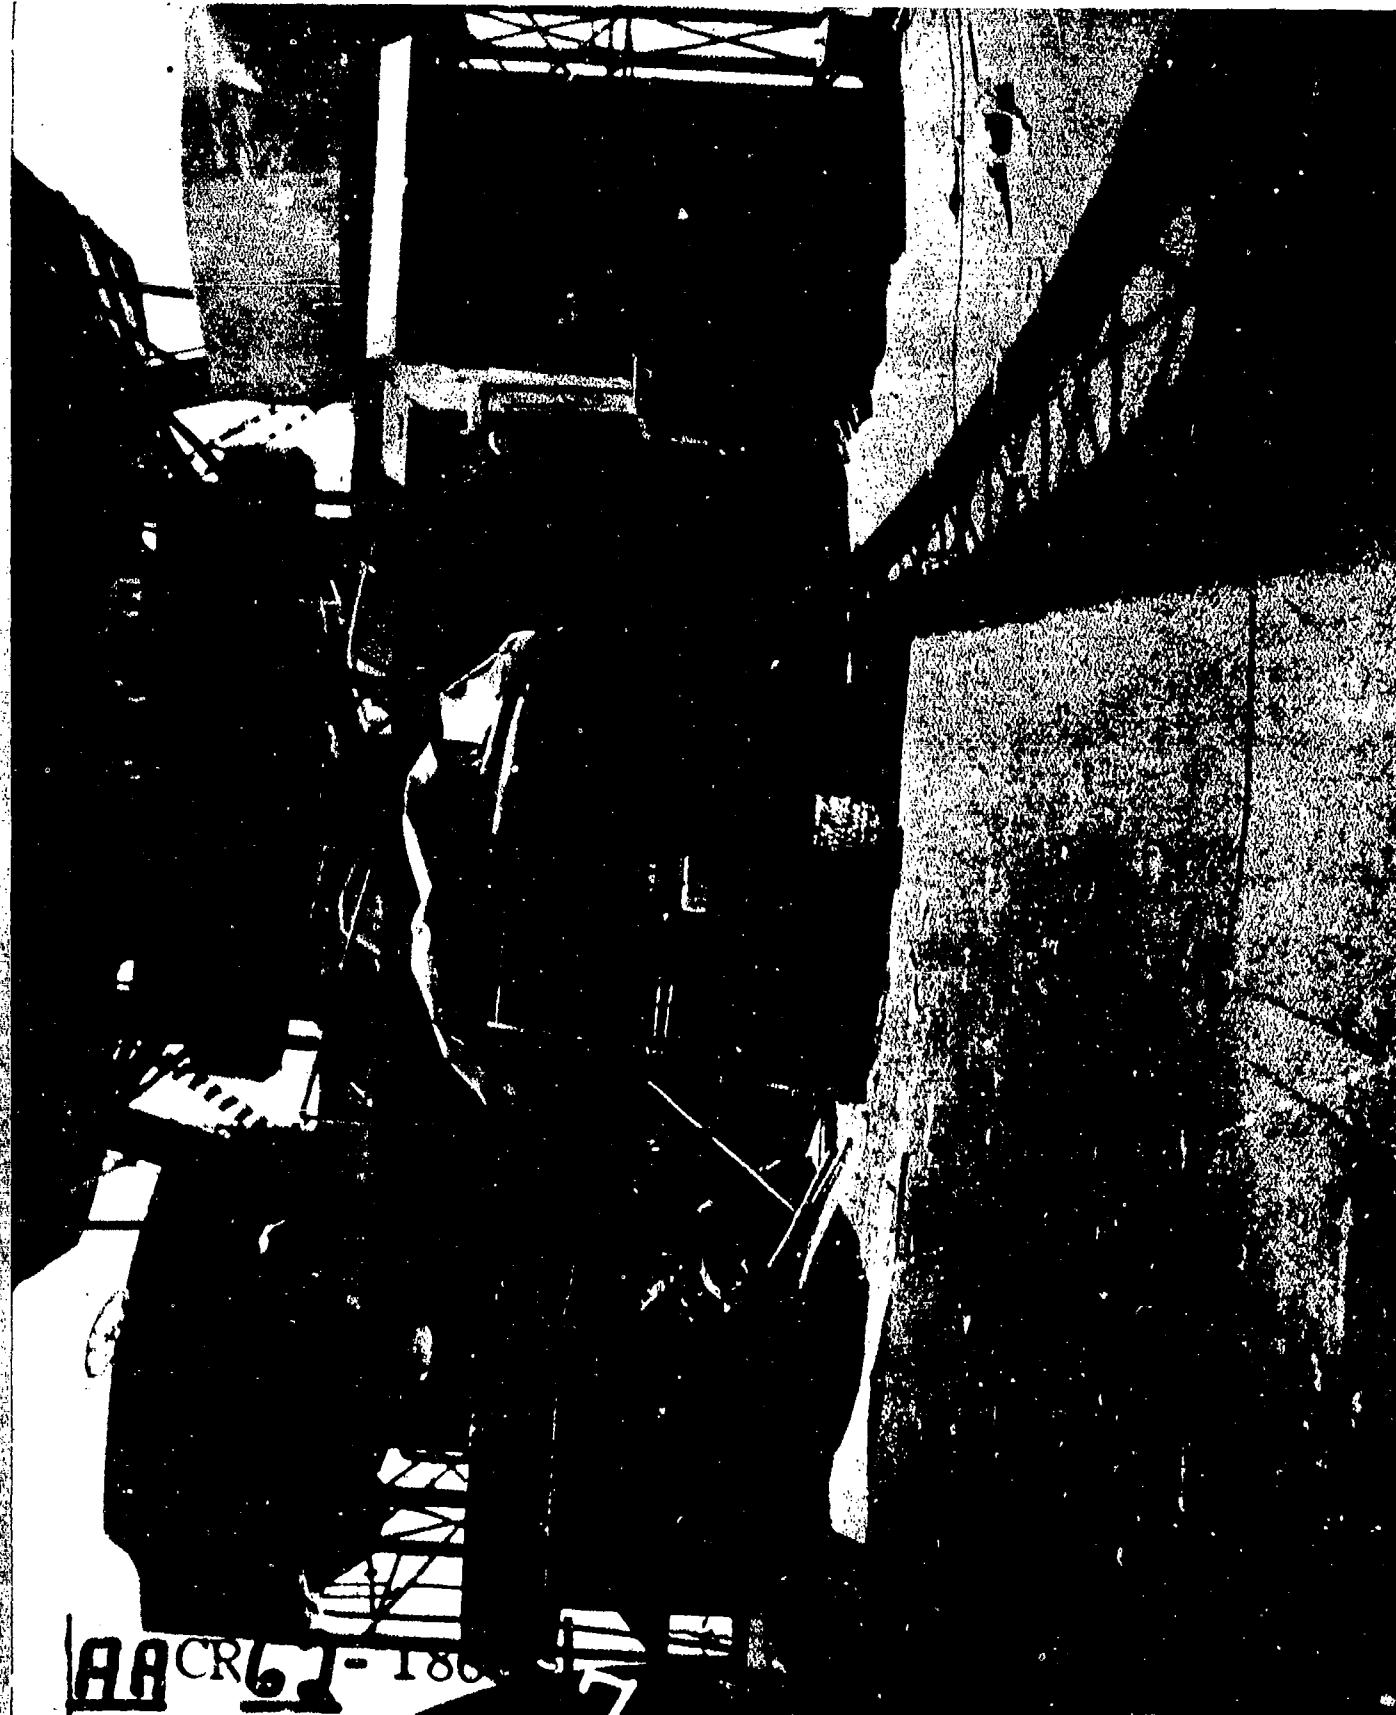
AA-CR-62-1866-7. Looking forward at deflection of main deck aft of frame 61 and at damage to superstructure.
